Report PAS-75-29

Marine Fouling of Titanium Heat Exchangers

by
Wayne L. Adamson

**PROPULSION AND AUXILIARY SYSTEMS DEPARTMENT
Annapolis
RESEARCH AND DEVELOPMENT REPORT**

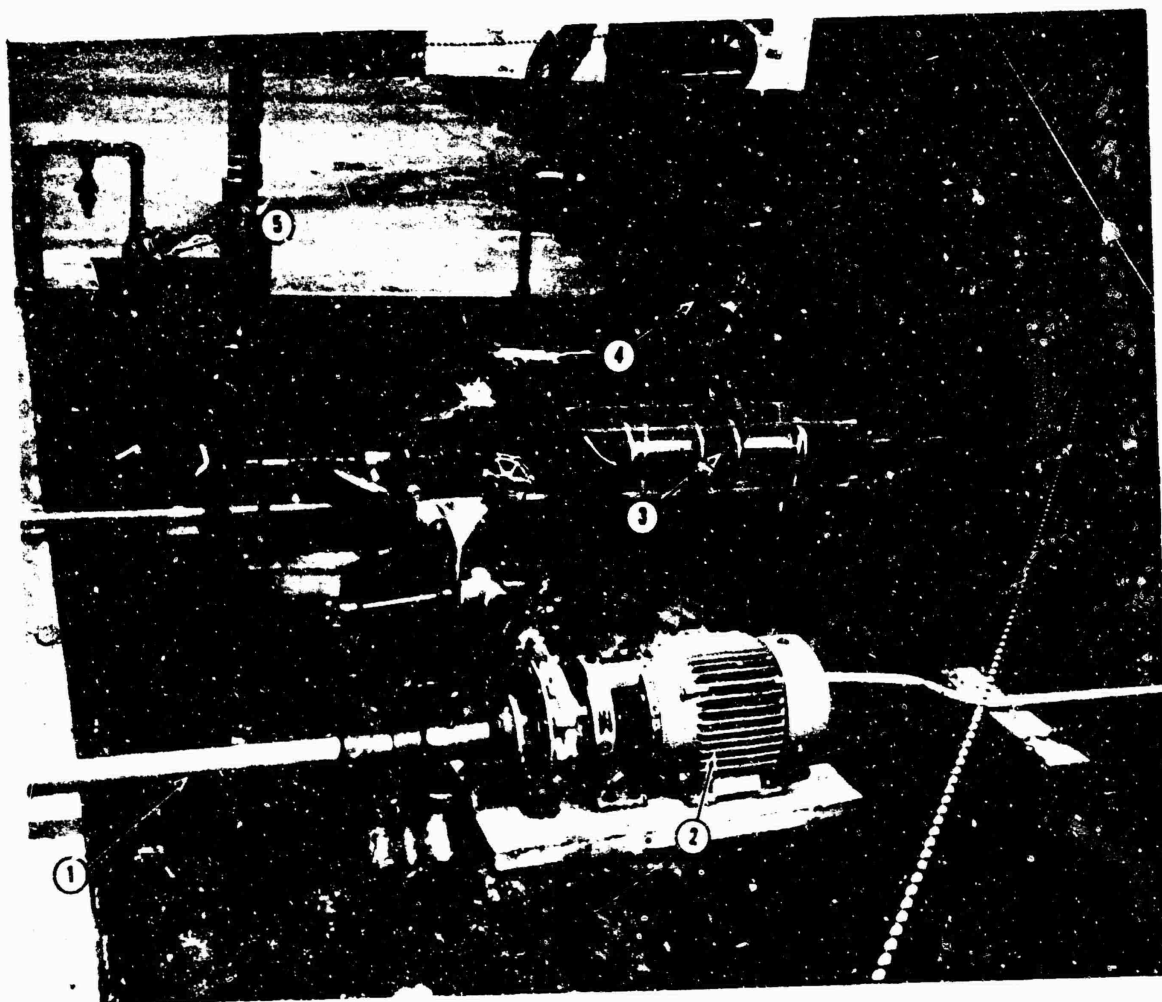
- 1 - Seawater Feed
- 2 - Pump and Motor
- 3 - Electrolytic Chlorinator
- 4 - Chlorinated Heat Exchanger
- 5 - Control (Unchlorinated) Heat Exchanger

Figure 1
Overall View of Fouling Test System

An overall view of the system used for the fouling studies is shown in figure 1. In the actual piping layout, figure 2, two identical single-pass titanium heat exchangers were operated in parallel seawater circuits. One heat exchanger (designated No. 1) was used as the control heat exchanger with no chlorine protection; the other, No. 2, was placed downstream from an electrolytic chlorinator. The heat exchanger, figure 3, consisted of six commercially pure ASTM grade 2 seamless titanium tubes 5/8-inch (1.59-cm) o.d., 0.035-inch (0.089-cm) wall, 30-inch (76.3-cm) length rolled into 6 aluminum - 4 vanadium (6Al-4V) titanium alloy tube sheets. The headers were also constructed of 6Al-4V alloy. Neither exchanger had a shell since it was desired to conduct tests without tube heating. Details of the construction are given in figure 4.

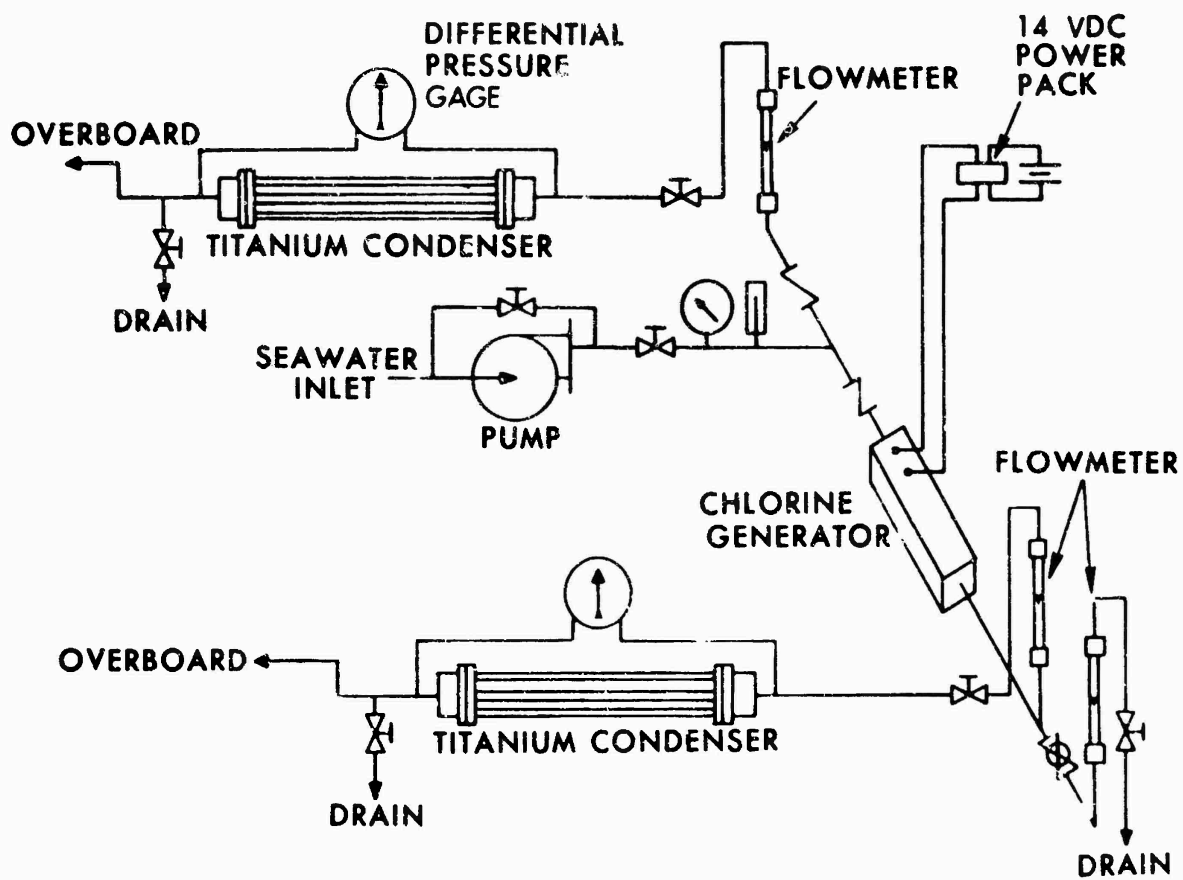
Figure 2
Piping Layout for Fouling Test

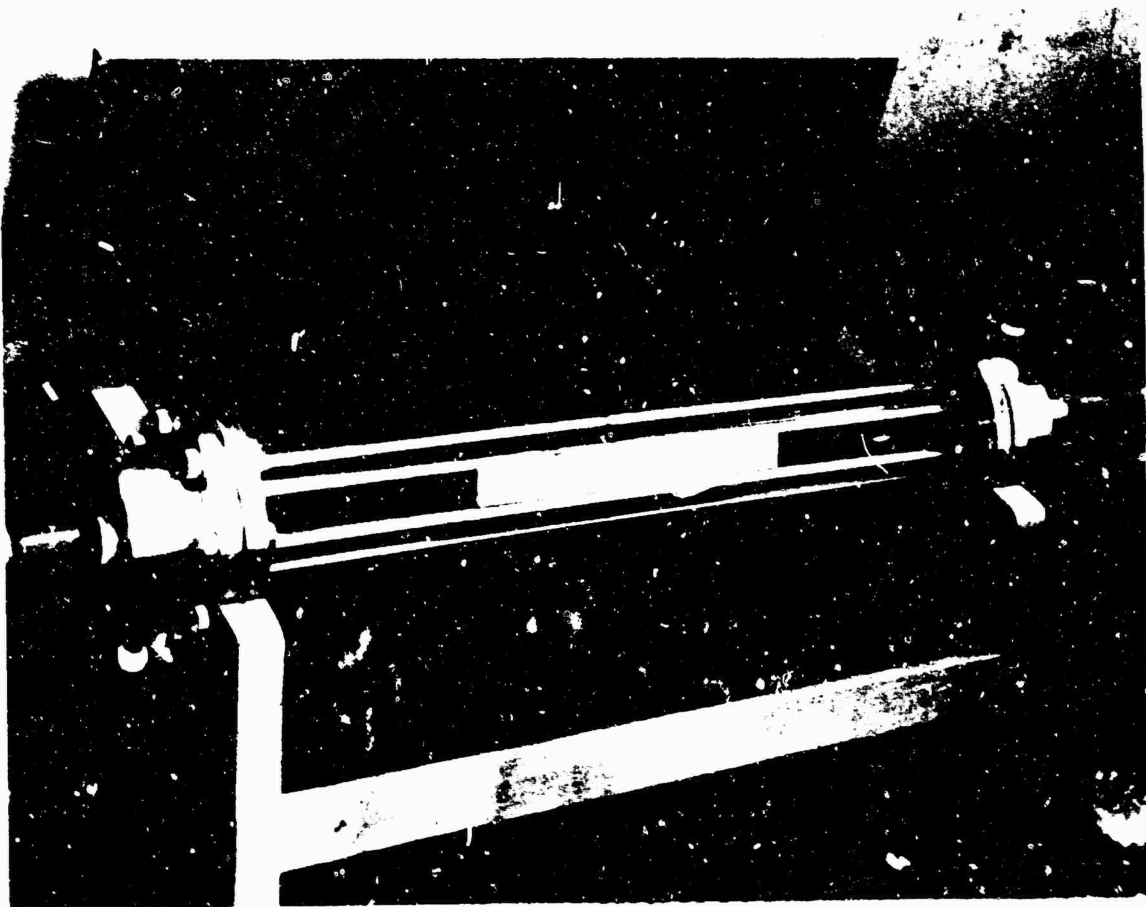
Figure 3
Titanium Heat Exchanger

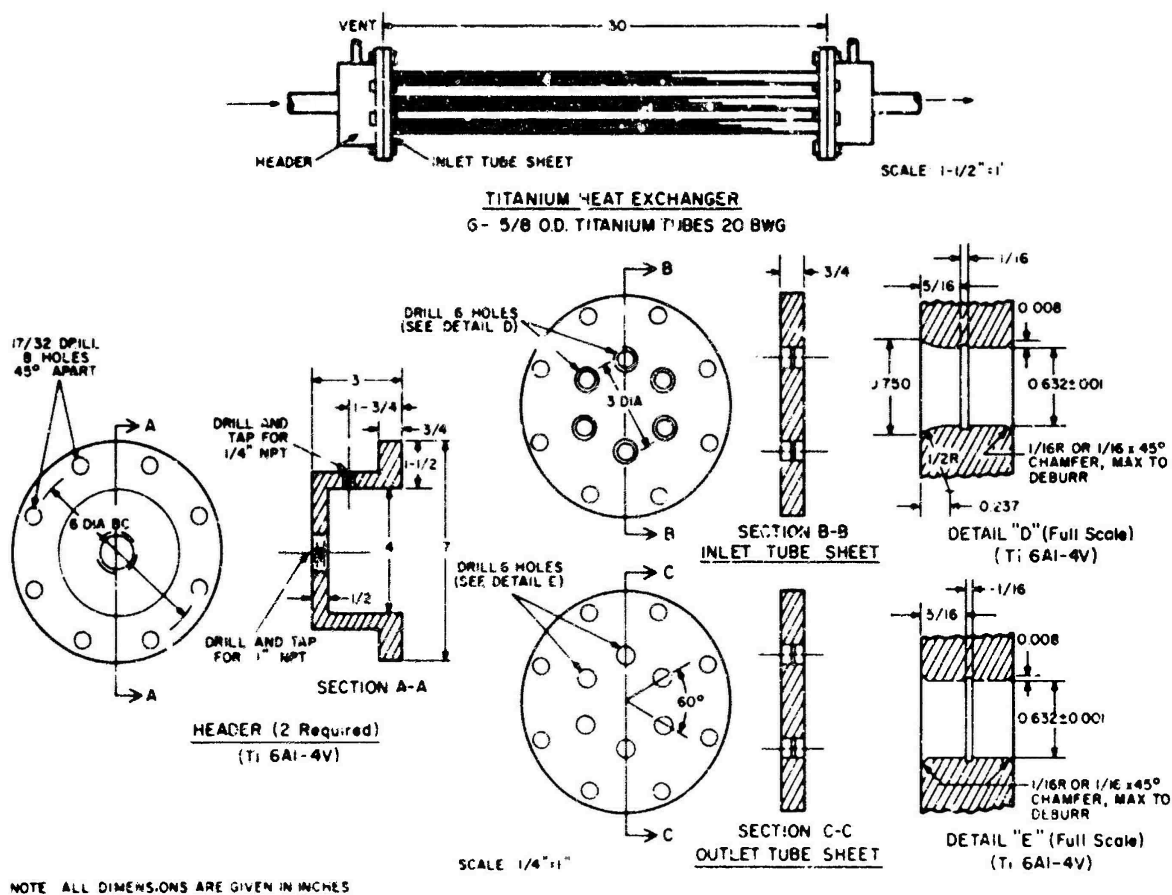
Figure 4
 Titanium Heat Exchanger Detail Drawings

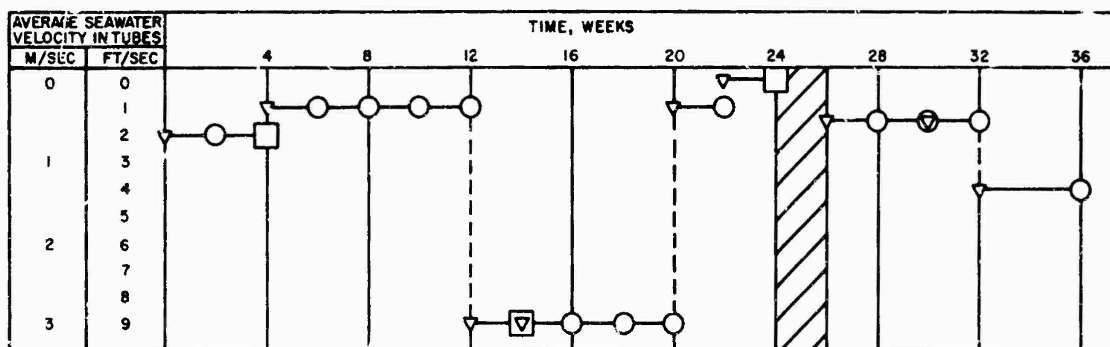
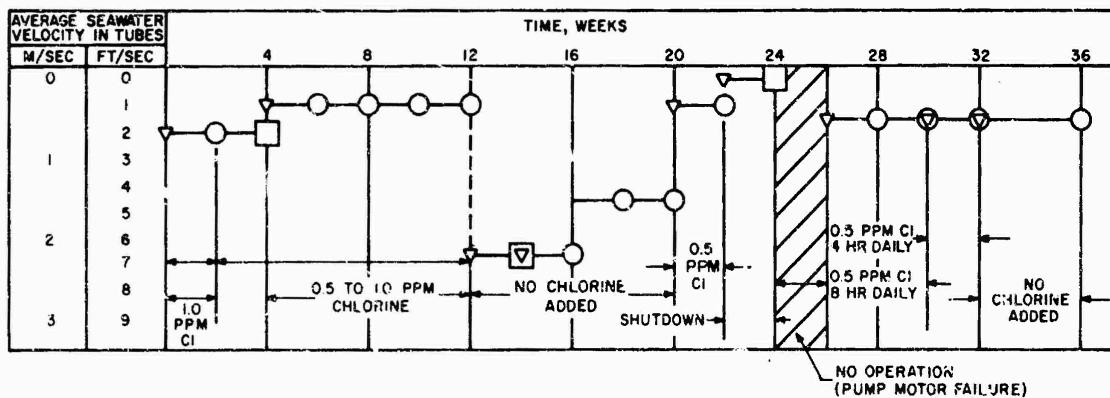
- ▽ BEGAN TEST RUN
- OPENED UNIT FOR INSPECTION ONLY
- UNITS INSPECTED AND CLEANED

CONTROL HEAT EXCHANGER (NO. 1)

CHLORINATED HEAT EXCHANGER (NO. 2)

Figure 6
Heat Exchanger Operating Schedule

A summary of the fouling test schedule is provided in figure 6. All test runs were conducted by Dow Chemical Company personnel as part of Navy contract N00600-74-C-0287. The initial runs (0 to 12 weeks) were conducted at low velocities with continuous chlorination of the No. 2 exchanger. These were followed by: a series of high velocity experiments (12 to 20 weeks), a run with a period of complete shutdown (20 to 24 weeks), some low velocity runs with intermittent chlorination (26 to 32 weeks), and a final run at intermediate velocity with no chlorination (32 to 38 weeks).

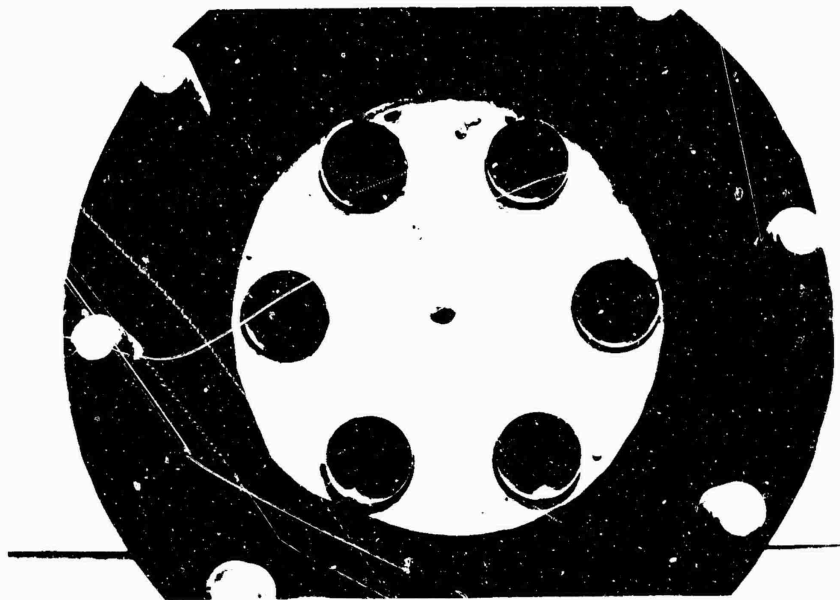
Figure 7 - Barnacle Fouling of Titanium Heat
Exchanger after 2 Weeks at
1 ft/sec (0.3 m/sec) Seawater Velocity

The initial runs, which were conducted at 1 and 2 ft/sec (0.3 and 0.6 m/sec) tube velocity in both heat exchangers, established the fact that marine fouling will occur in titanium heat exchangers, both inside the tubes and on the tube sheets and headers, figures 7 and 8. The species of fouling organisms were principally barnacles with some colonial hydroids. Fouling occurred on the control (No. 1) heat exchanger, whereas the No. 2 chlorinated exchanger remained void of any marine growth, figure 9. In spite of the fairly extensive buildup of marine life in the tubes, no problems were encountered in mechanical cleaning with the wire brush. Attachment did not appear to be as tenacious as might often be found with other tube materials.
